Assessment of Dam Safety

Coal Combustion Surface Impoundments (Task 3)

PacifiCorp

Naughton Power Station

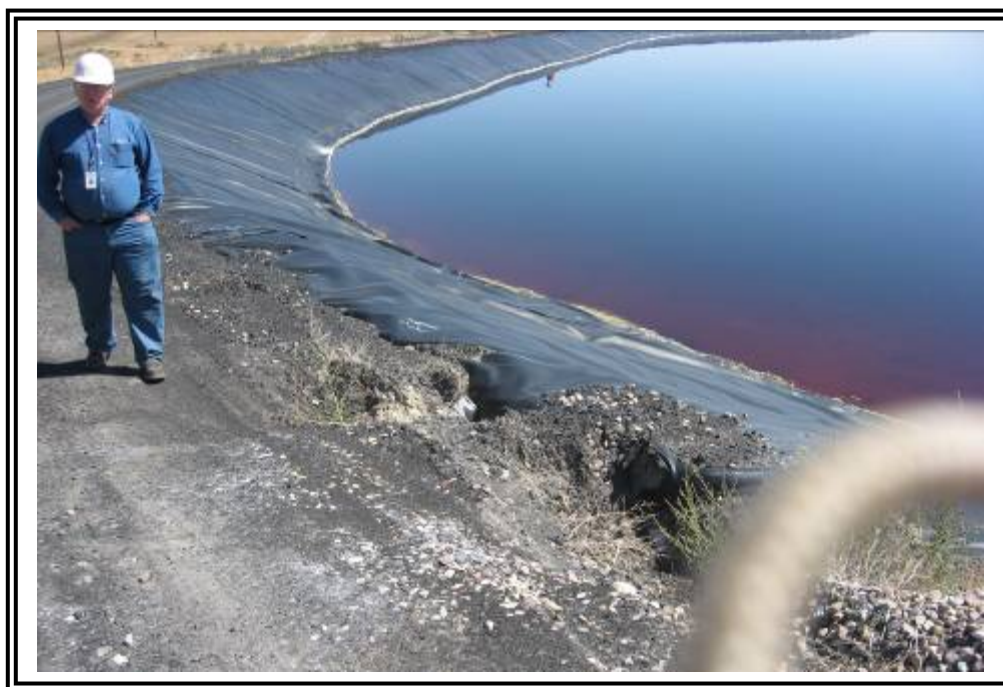
3

The upstream slope is covered with a 30 mil PVC liner as shown in Photos 1, and 18. A couple of depressions were noted on the upstream slope/crest intersection at the north end of the northeast dike as shown in Photo 3. PacifiCorp representatives indicated this was an area where sluice lines had formerly been laid, and that some frost heaving issues had occurred. The access road on the crest was re-graded, but the resulting depressions at the top of the upstream slope were not repaired.

Depressions on upstream slope/crest at north end of northeast dike.

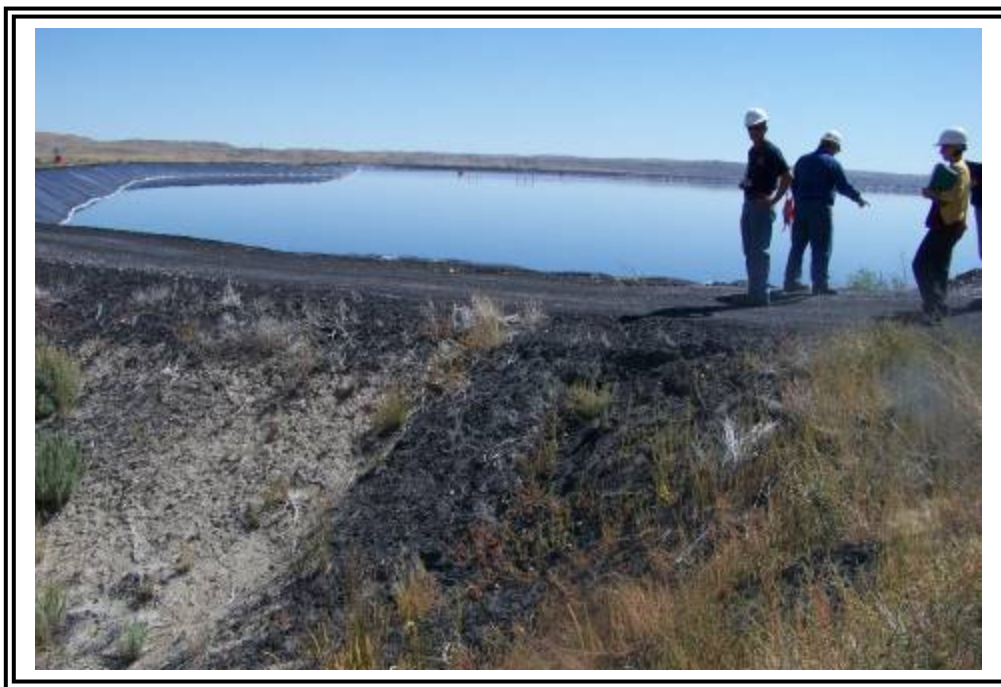
5

Erosion rivulet at north end of northeast dike adjacent to access road ramp to toe of dike.

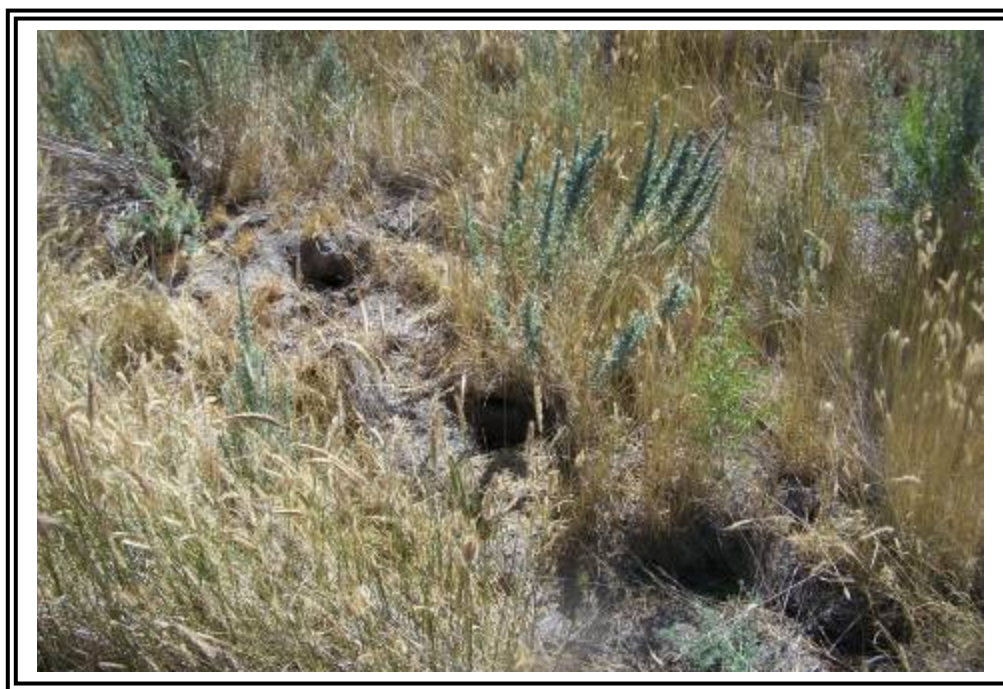
9

Animal burrows along toe of northeast dike (northern end of dike).

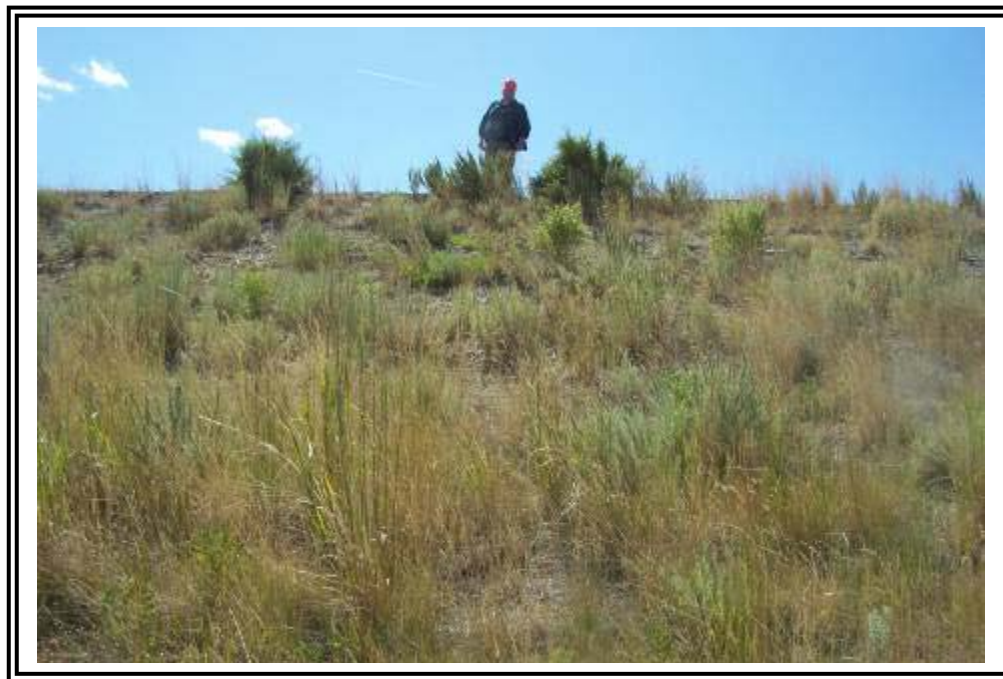
Near the mid point of the northeast dike, a crack, about 65 feet long was observed about 12 feet below the crest elevation. This crack was generally parallel to the slope and could be penetrated with a rebar probe up to about 2 feet in some areas. Photos 10 and 11 show the area and appearance of this crack.

Slope erosion rivulets and irregular surface on downstream slope at about mid point of northeast dike (area of crack).

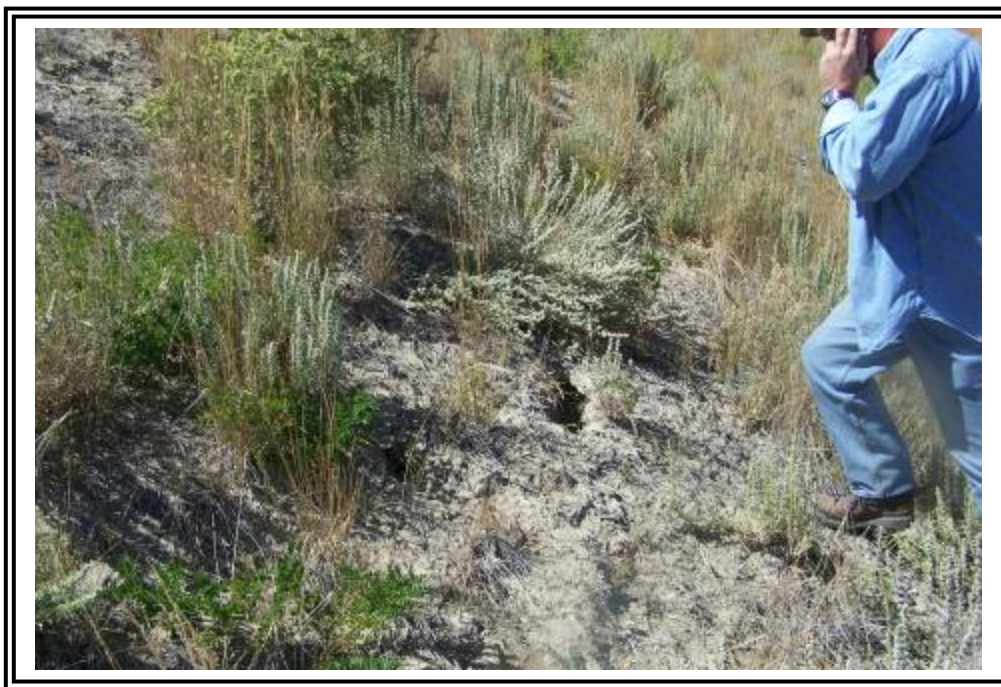
11

Depressions along 65-foot long crack observed at about mid length of northeast dike.
Crack located about 12 feet below the top of the dike.

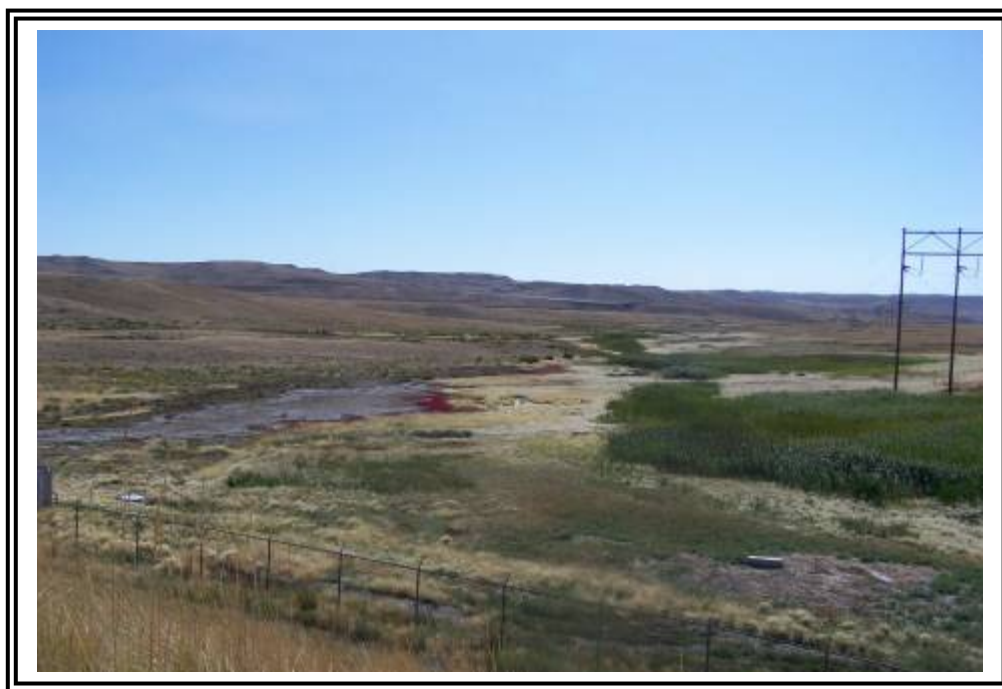
37

chemistry. The leak was hypothesized to be below the FGD byproducts and therefore, deemed impractical to repair. To contain this seepage on site, a cutoff/seepage collection trench of crushed stone lined on the downstream side with a geomembrane was installed. Seepage water is collected in this trench and then pumped back to the FGD #2 Pond. PacifiCorp expects compressing/settling FGD byproducts to have a decreasing permeability and personnel accompanying CHA in the field indicated a reduction in pump back volume has occurred since the installation of the system. The area of the pump back system and original seepage is seen in Photo 37.

Downstream toe area at south corner. Area of seepage pump back system.

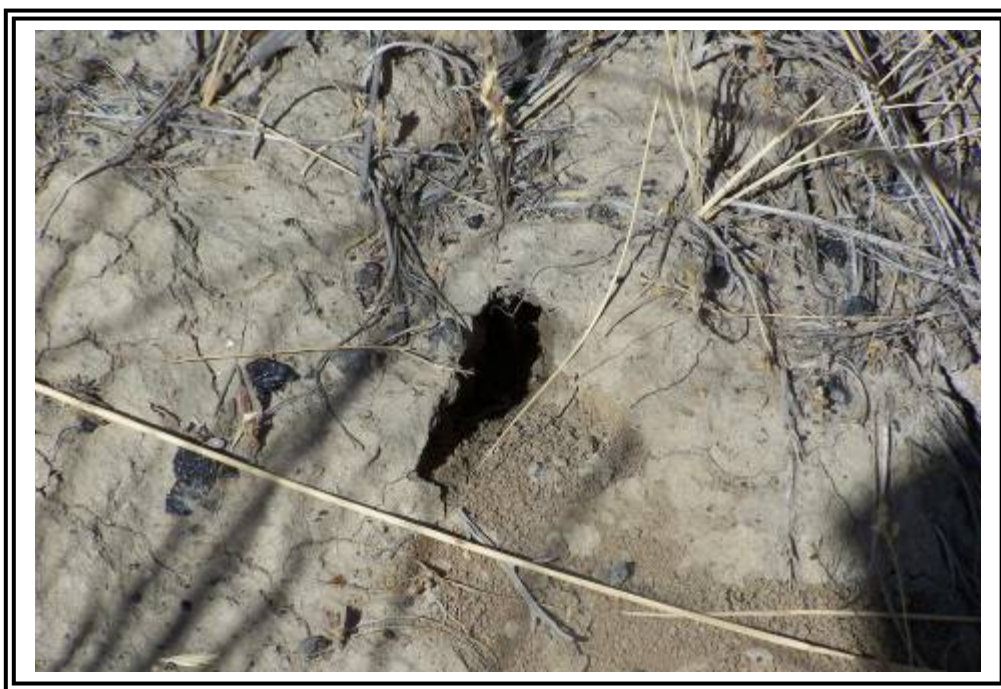
41

Animal burrow on east dike.

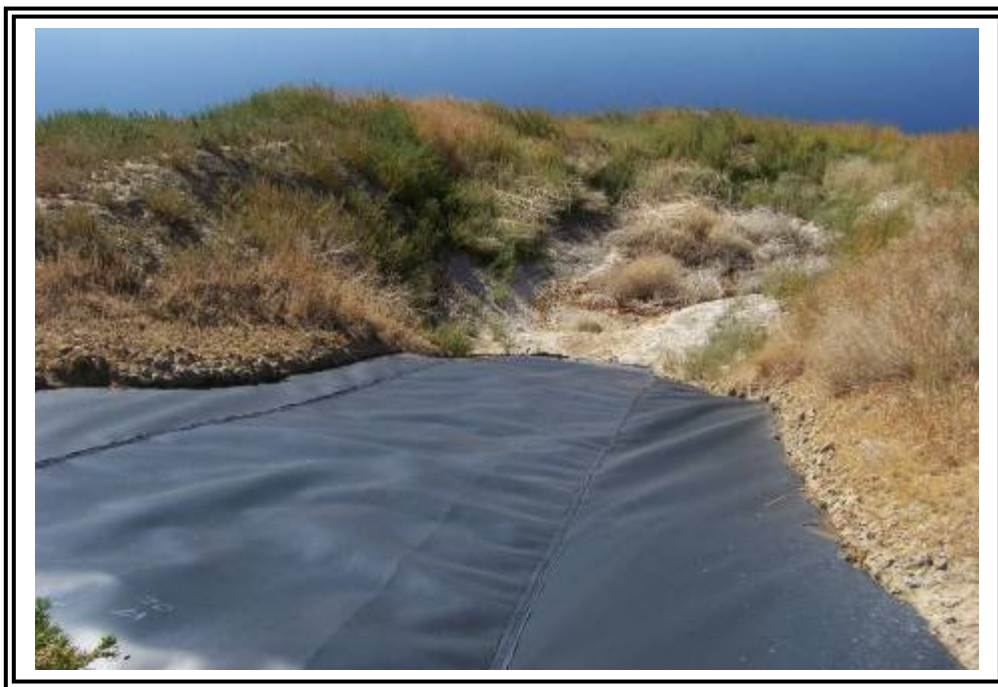
49

Patch along seam in upstream liner along north dike. Soil on top of liner remnant of coffer dam built for repair.

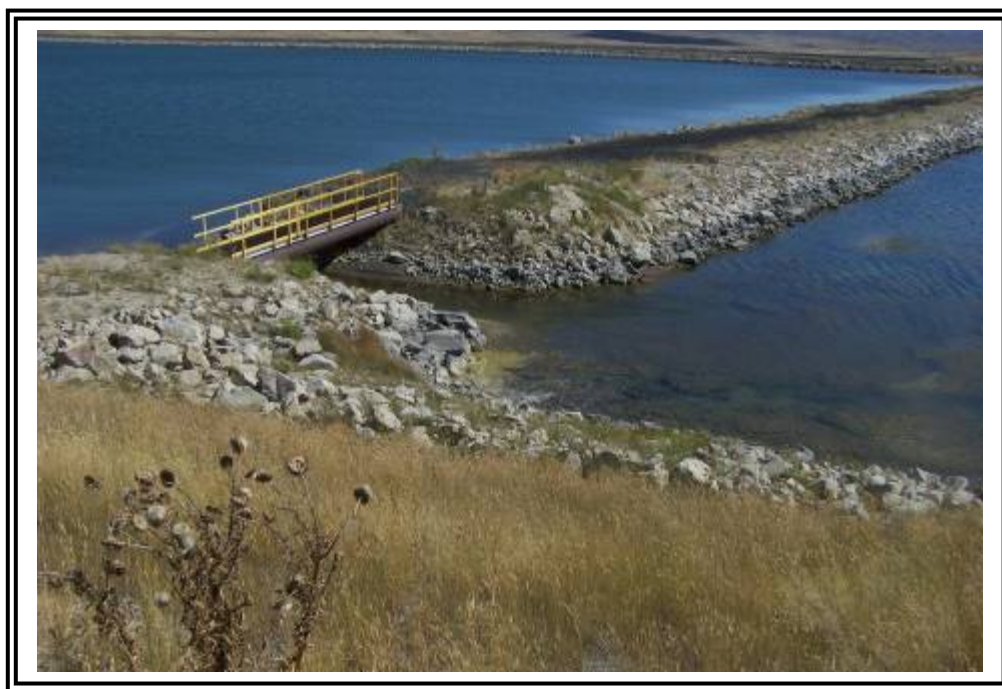
55

Breached dike separating the east and west Clearwater Ponds.

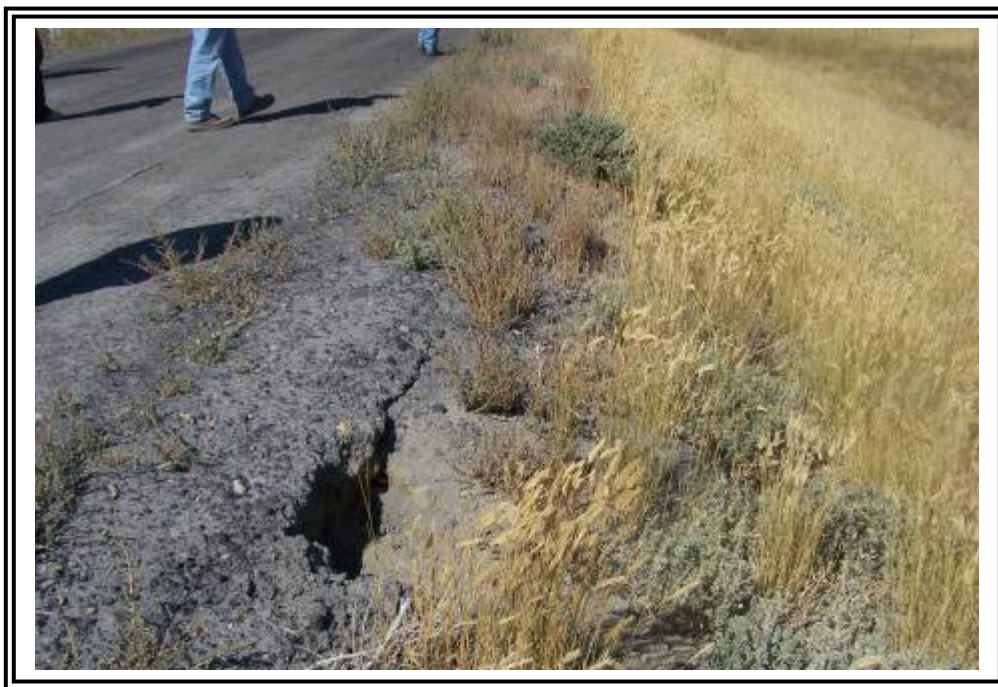
65

Animal burrows were observed in several locations on the downstream slope of the intermediate dike such as shown in Photos 58 and 68. Near the northeast corner of the Intermediate Dike, a crack was observed adjacent to an animal burrow as shown in Photo 65. The crack appeared to be related to the grading of the access road material.

Cracking and animal burrow or sinkhole on Intermediate Dike. Appears to be related to access road material.

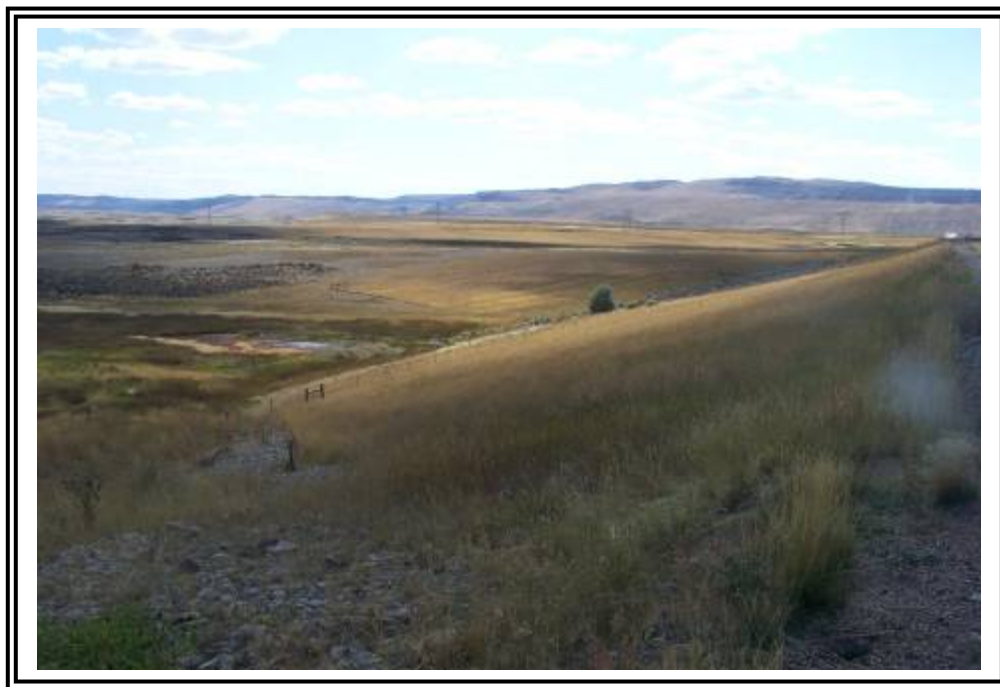
Seepage has been observed and studied in the past in the area of the east groin of the Main Dike. Photo 71 shows the groin with protective rip rap. Studies by Cornforth Consultants suggest that the observed seepage is from groundwater running along near surface bedrock. Sloughing has been observed in the natural ground beyond the Main Dike, but has not impacted the integrity of the Main Dike.

East groin Main Dike.

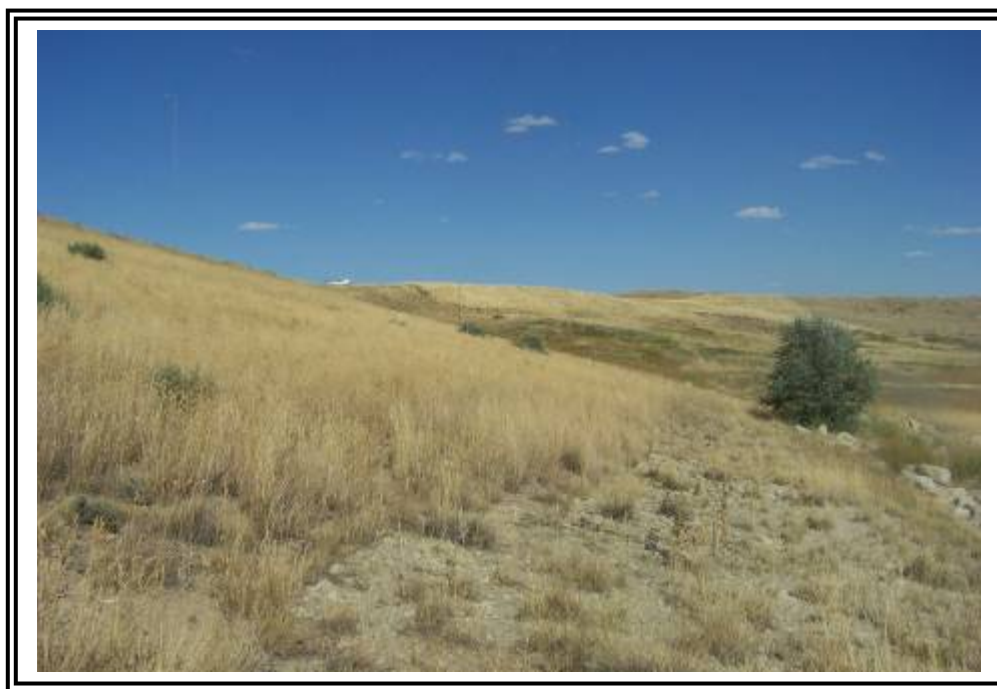
79

Occasional erosion rills, animal burrows, and sage bushes were observed on the downstream slope of the Main Dike. These types of features are shown in Photos 73, 79, and 82. The downstream toe contains a blanket drain that daylights at the toe based on details on drawings provided for review. This lower area of the embankment is protected with small rip rap.

Downstream slope of Main Dike. Sage bushes to be removed.

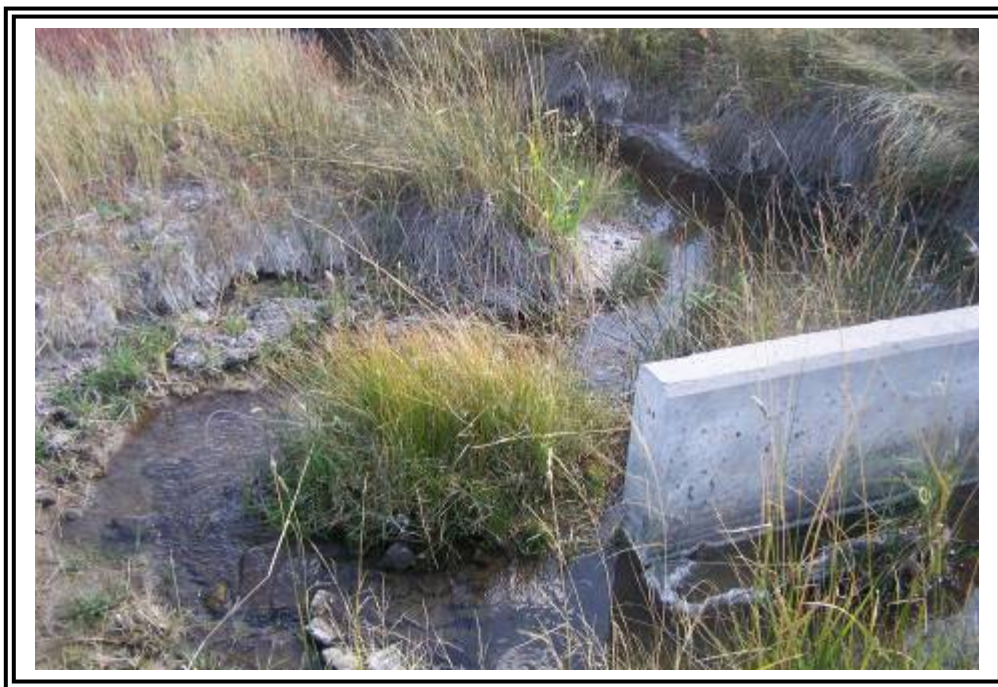
81

across which the Main Dike was constructed. A V-notch weir was observed in the downstream channel, but flow has eroded around the weir and is no longer going through the weir. It is unclear why this weir structure is in place, which is shown in Photos 80 and 81. PacifiCorp indicated that this weir is located on Bureau of Land Management Property and is not associated with the North Ash Pond.

Discharge channel bypassing weir structure located on Bureau of Land Management property.

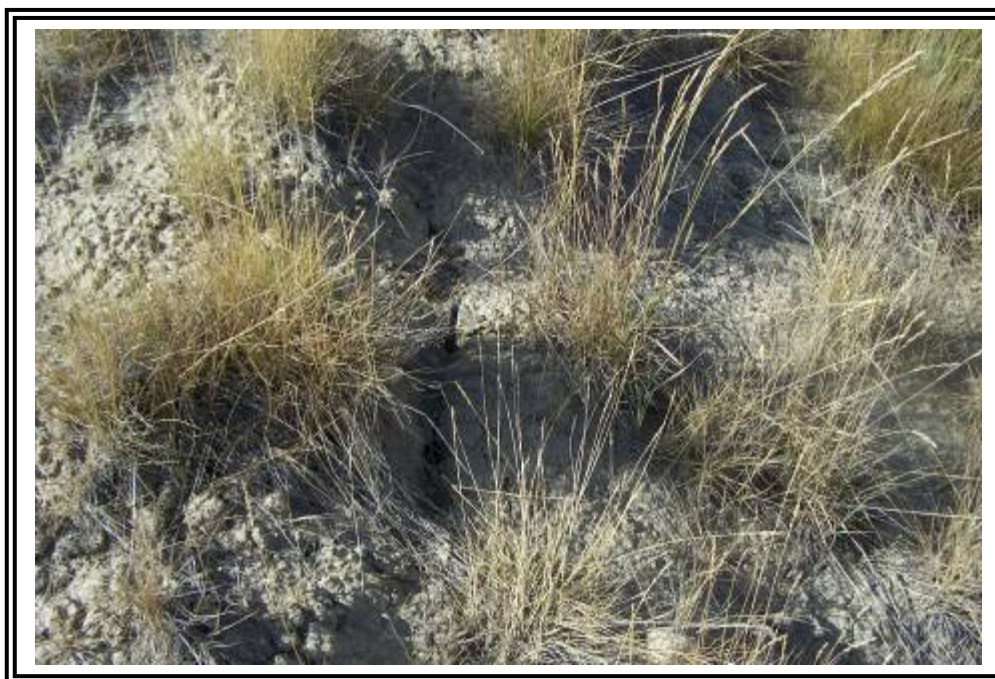
The East Saddle Dike does not fully impound water but provides freeboard storage. The upstream slope of the East Saddle Dike is covered with rip rap as shown in Photos 84 and 90. The crest and downstream slope are covered in crested wheatgrass as shown in Photos 85 and 88. An intermittent, but somewhat continuous, linear crack was observed at the crest/downstream slope intersection as shown in Photos 86 and 87.

Crack at crest/downstream slope of break. Crack appeared intermittently along the length of the East Saddle Dike.

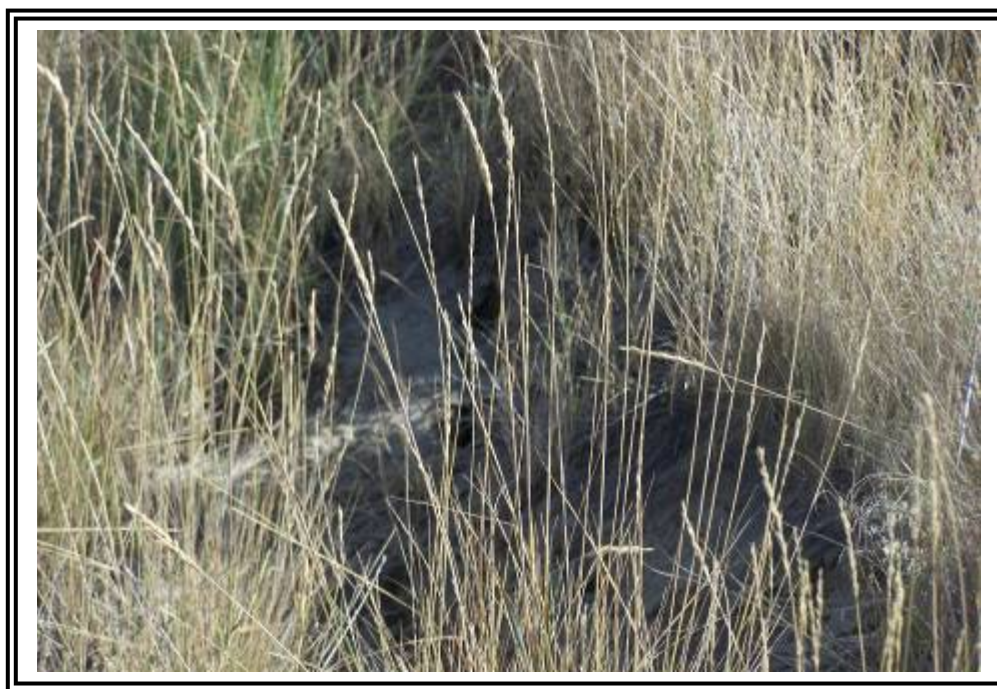
87

Crack at crest/downstream slope of break. Crack appeared intermittently along the length of the East Saddle Dike.

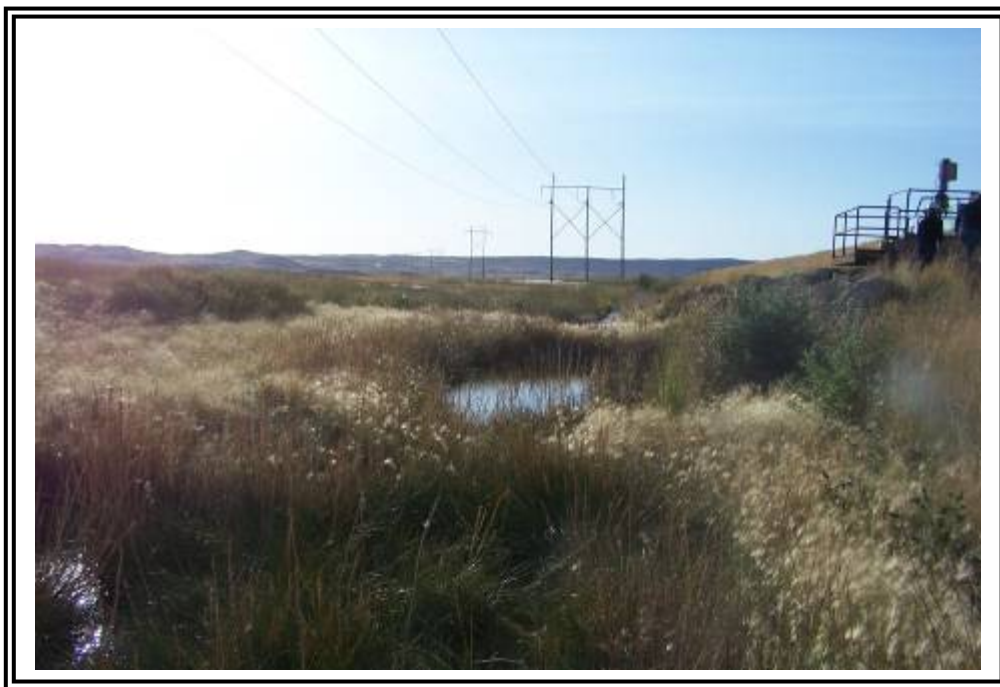
95

Standing water at toe of northeast dike “upstream” of discharge channel.

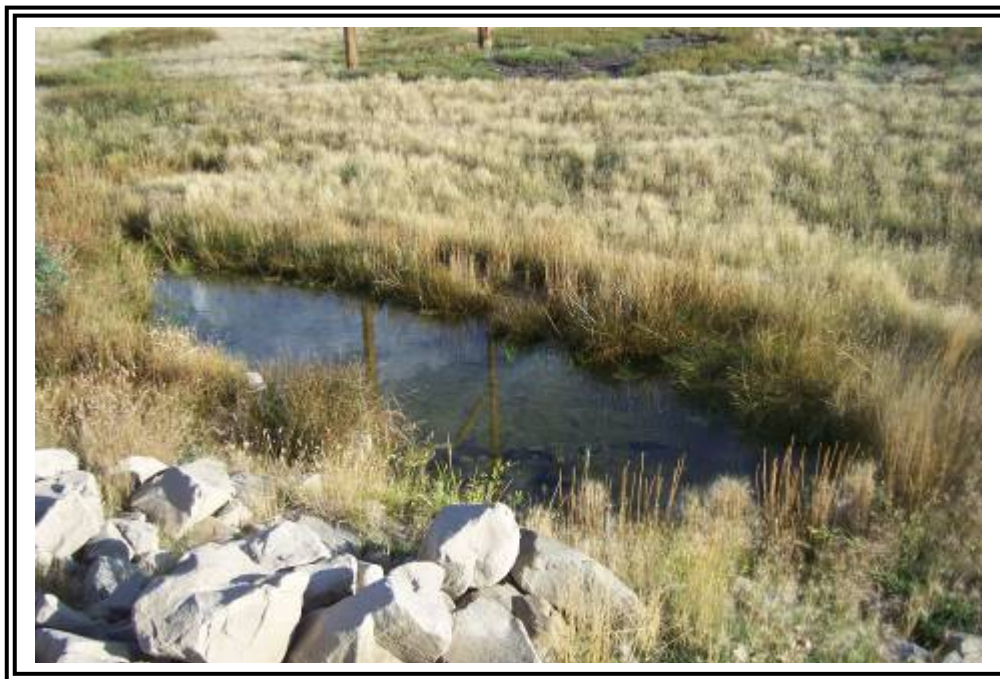
Standing water "upstream" of discharge channel. Plant personnel indicated outflow from pond sometimes higher than during CHA site visit that may back-up into this area. No flow in water observed by CHA.

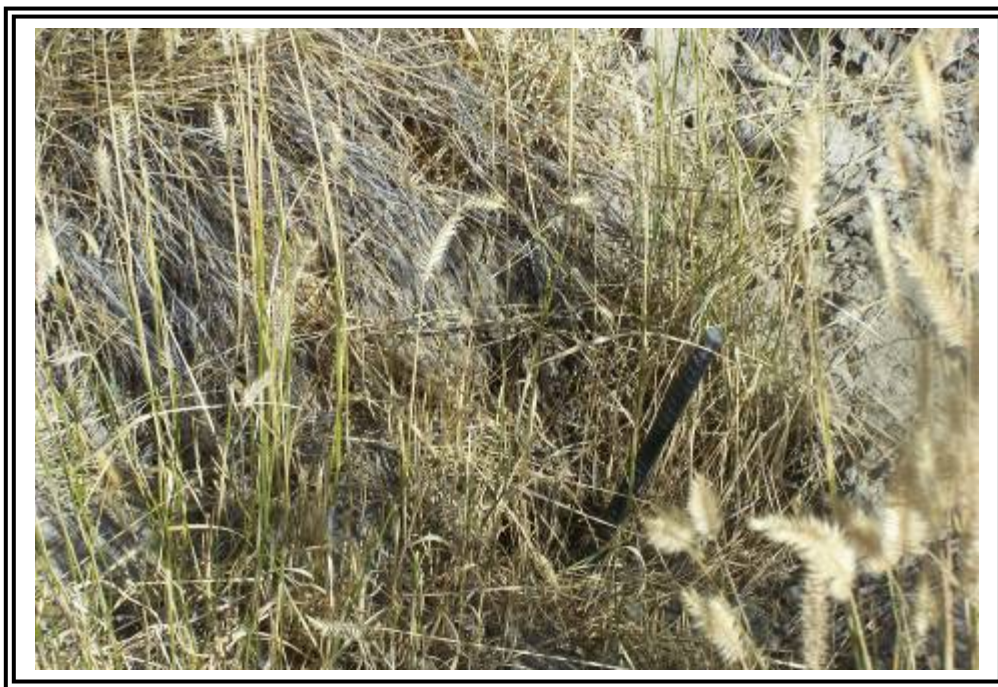
125

Occasional animal burrows were observed as shown in Photos 104, 112, 117 and 125. Occasional erosion rills were also observed as shown in Photo 124.

Animal burrow obscured by vegetation.
